**Asbestos and Lead-Based Paint  
Abatement Completion Report  
Heart Butte Government Square  
Heart Butte, Montana**

February 1, 2021

**Subject: Asbestos and Lead-Based Paint Abatement Completion Report  
Heart Butte Government Square, Government Square Loop  
Heart Butte, Pondera County, Montana**

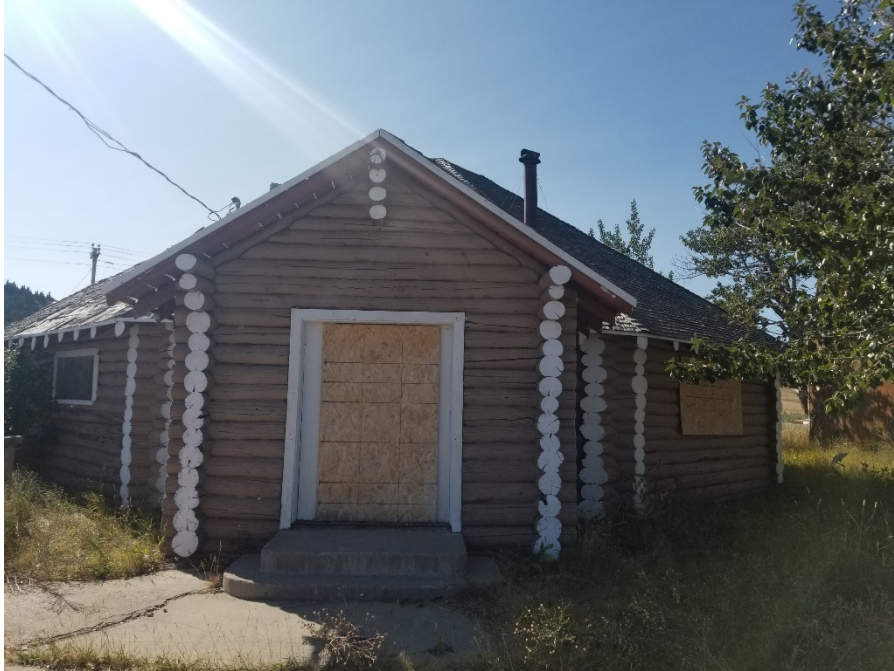
Photo 3. Project close-out photo for lead abatement and repainting of log ends and framework on the main entrance of the Round Hall.

- The scope at the Round Hall increased a bit to include repair and painting of all log ends in addition to the front entrance, as directed by the BEO.

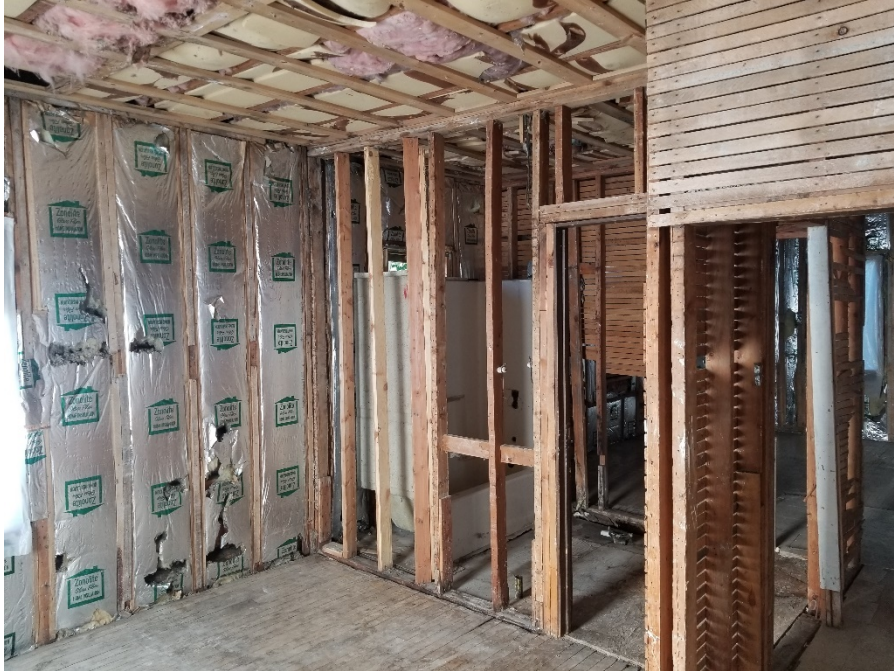
Photo 5. Final clearance photo of Rutherford House interior following removal of sheetrock wall and ceiling materials.

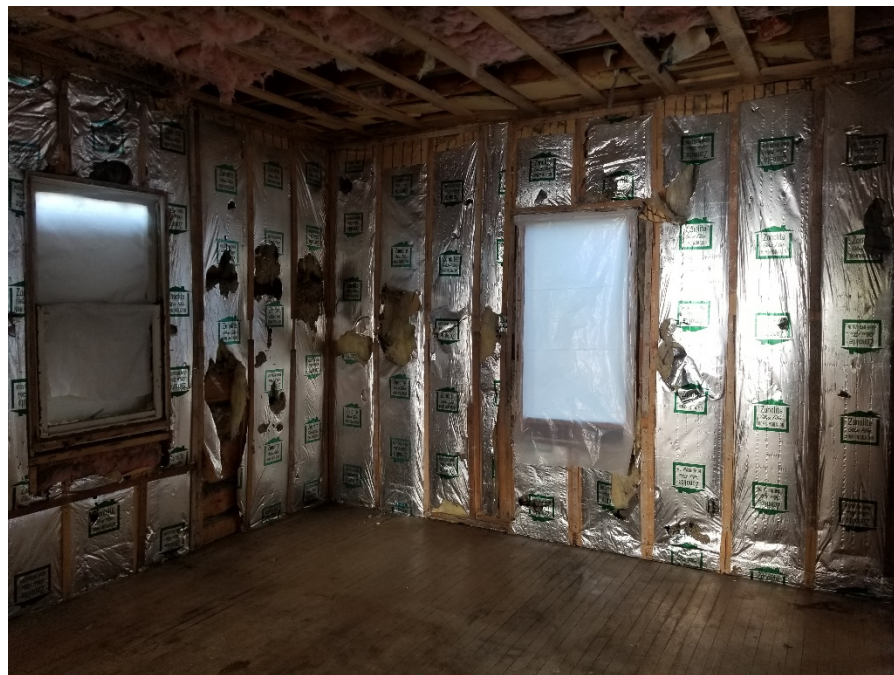
Photo 6. Final clearance photo of Rutherford House interior following removal of sheetrock wall and ceiling materials.

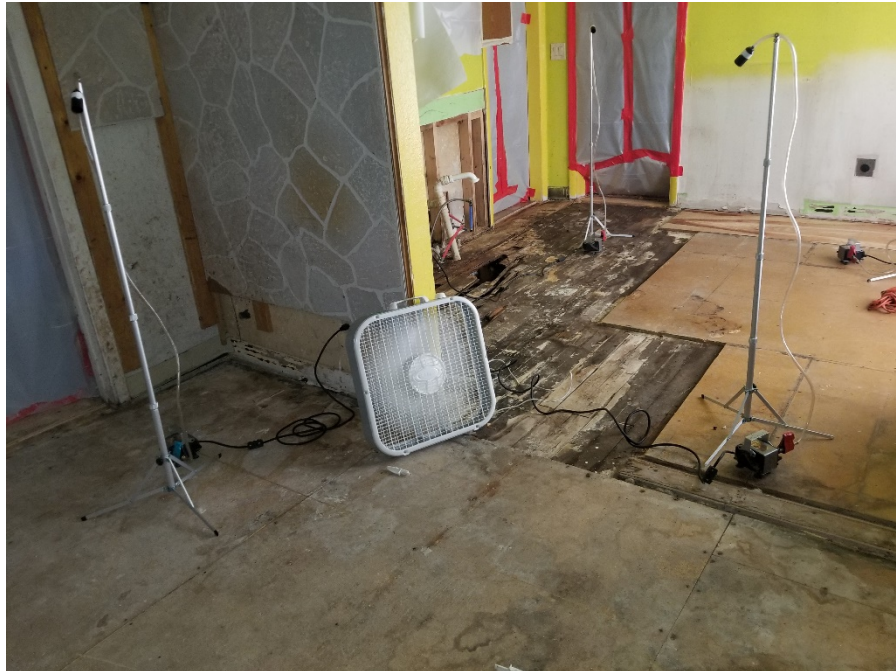
Photo 7. Final clearance air sampling following asbestos abatement within the Comes at Night House.

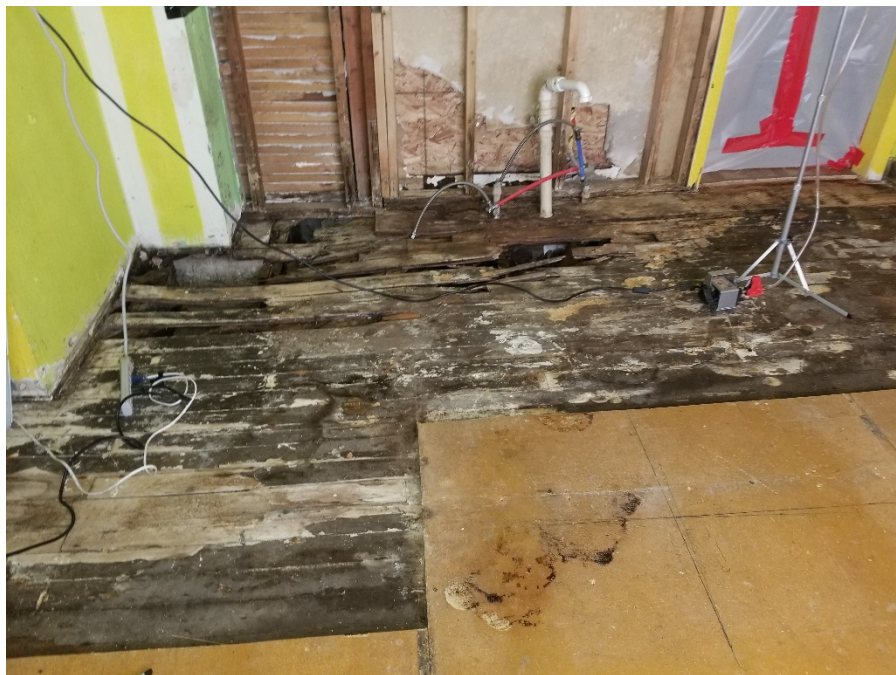
Photo 8. Water damaged subfloor materials in the Comes at Night House kitchen. Owner will be responsible for removal of moldy wood subfloor.

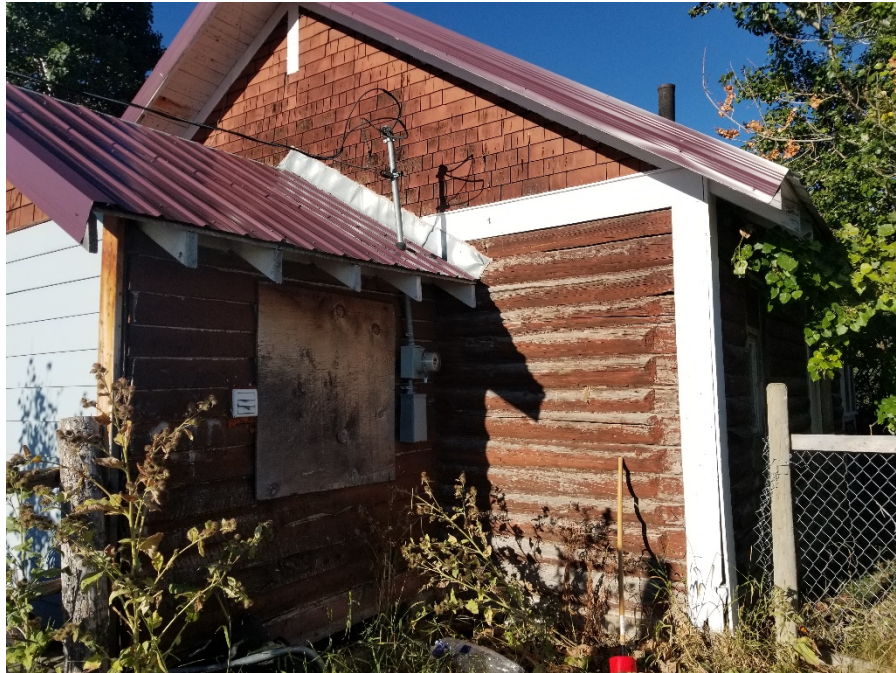
Photo 9. Project close-out photo for lead abatement and repainting of exterior trim on the Comes at Night House

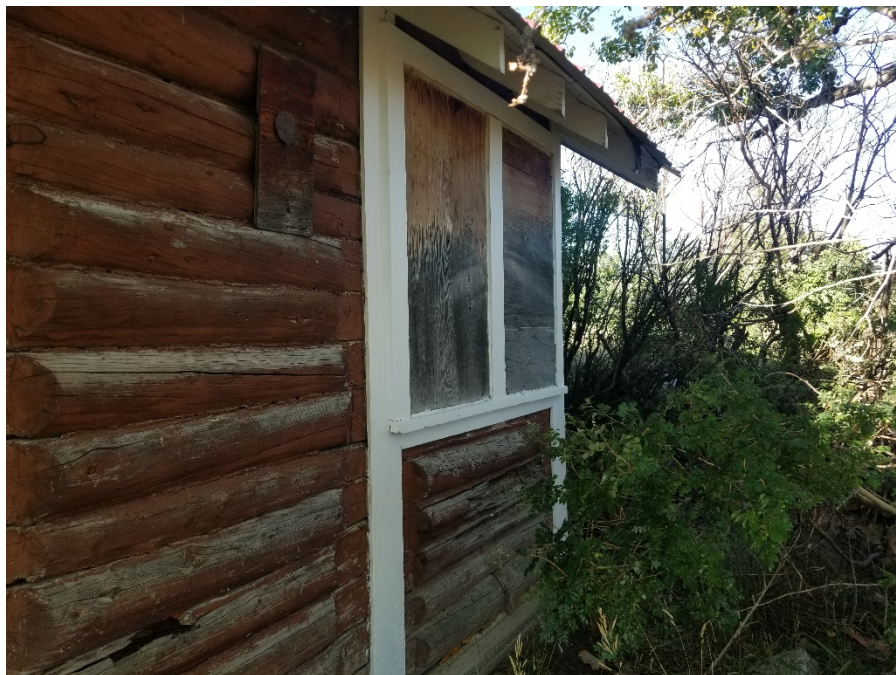
Photo 10. Project close-out photo for lead abatement and repainting of exterior window trim on the Comes at Night House.

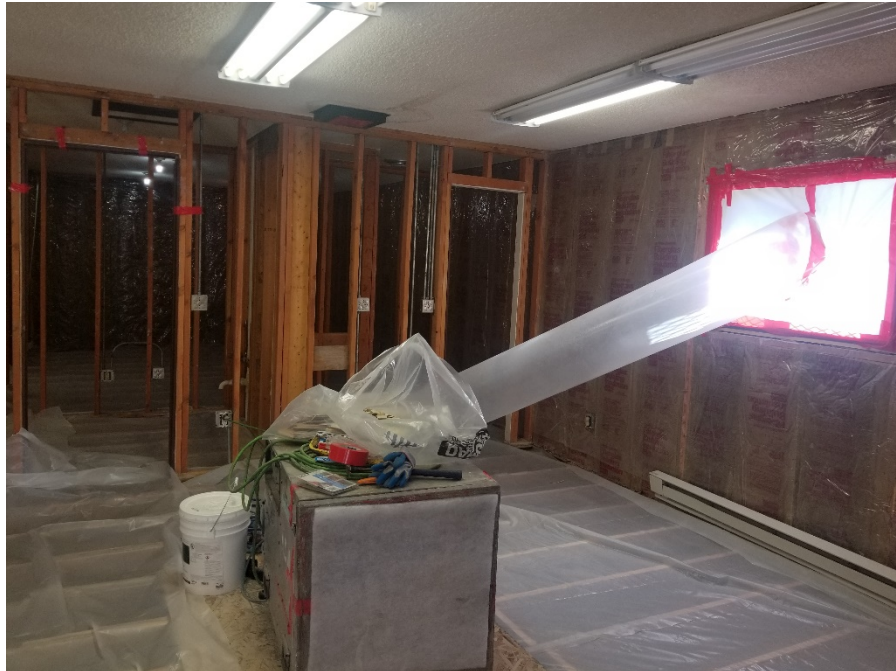
Photo 11. Final clearance project photo taken inside the Community Center looking northwest.

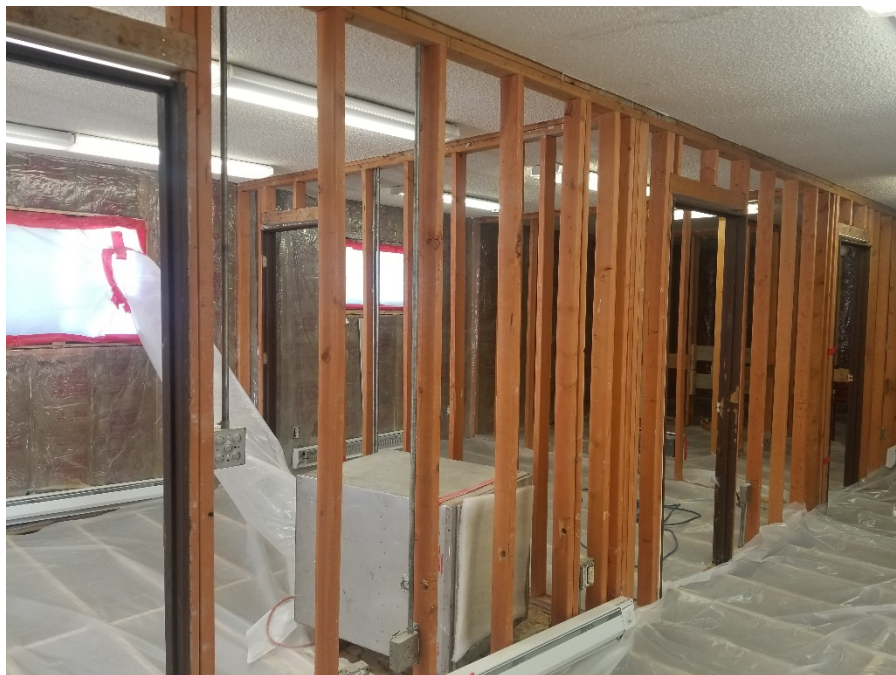
Photo 12. Final clearance project photo taken inside the Community Center looking southwest.
